<b>NIOSH LODD Review</b>	 
LODD 2012-08	<a href="http://firetrainingtoolbox.com">http://firetrainingtoolbox.com</a>	LODD 2012-08

A summary of a NIOSH fire fighter fatality investigation

October 11, 2012

# Volunteer Lieutenant Killed and Two Fire Fighters Injured Following Bowstring Roof Collapse at Theatre Fire – Wisconsin

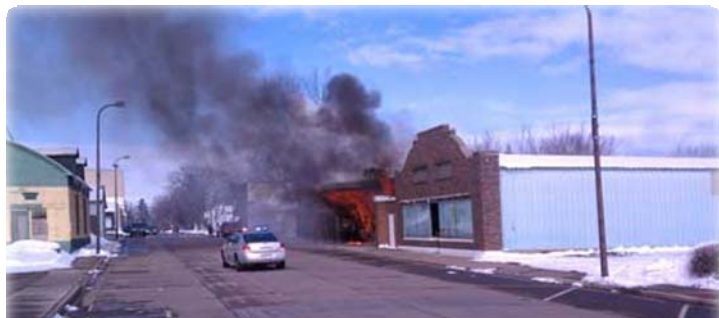
**Incident scene when fire was first discovered.**  
(Photo courtesy of Julie Miklaszewicz.)
