**TGI-Safety Bulletin**

To go along with the research study released by NYU-Poly in relation to lightweight construction during fire conditions, I wanted to share with everyone an incident that happened at White River Township FD. On August 31, 2008, crews were dispatched to a house fire. Upon arrival it was found that the mulch landscaping at the front of the house was on fire and extending up the vinyl siding. Crews knocked down the fire on the exterior and a second engine crew went to check the interior of the house and upon entering the basement found heavy smoke and fire conditions running the ceiling. After extinguishment of the fire it was found that numerous wooden I-beams, better known as Truss Joist I-Beam (called TGI because it is easier to say) were sagging and it was noted for all personnel to stay away from affected area. The TGI were unprotected and had burned through the OSB web. Pictures below show the damage to the exterior and floor assembly.

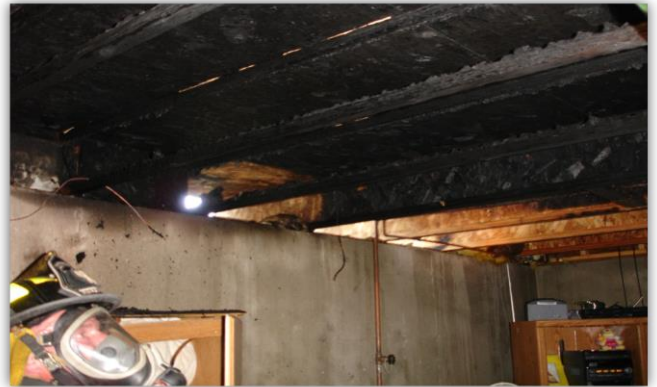
*Basement view showing unprotected TGIs.*

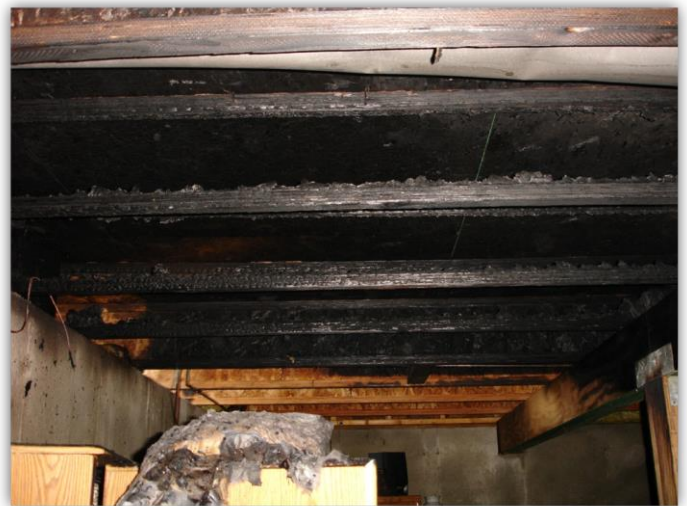
*Complete burn thru of OSB web. 1<sup>st</sup> flooring decking being supported only by the chords.*

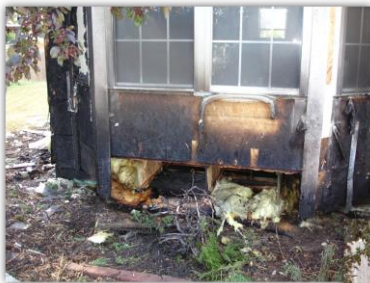
*A/B Corner where exterior fire started*

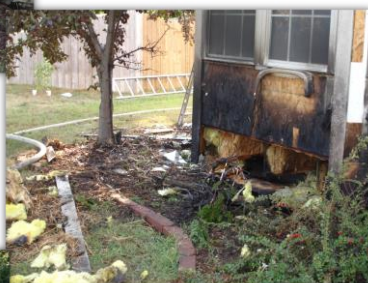
*Another view from point of origin*

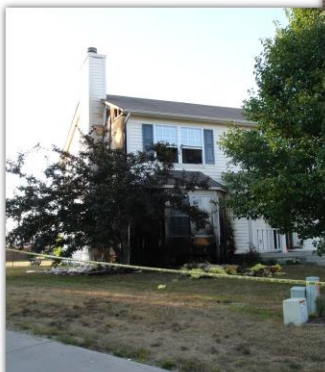
*A/B corner from street*
