# SAFETY BULLETIN

Dale Saucier, Chief of Training and Safety  
White River Township FD, Indiana

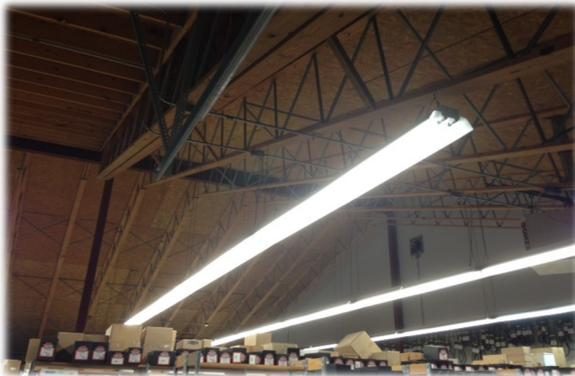
In this picture, you can see the LW wood truss system spanning a large distance with no structural support posts or columns. 2" x 4" upper and lower chords (laying flat) with metal rod webbing. Metal "I" beam in the ridge area with "I" beams for the structural columns. Orientated strand board roofing decking adorns the top.

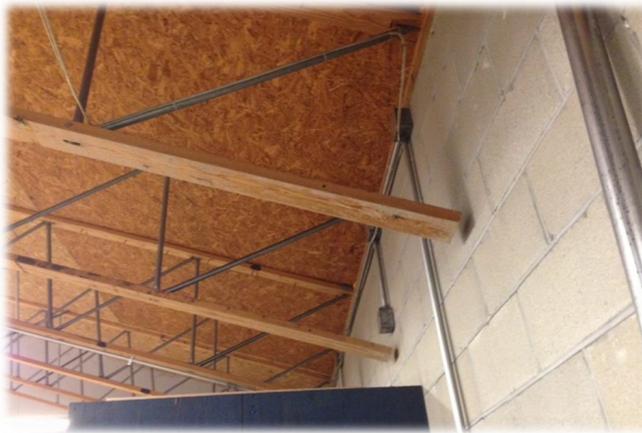
This is where I am amazed and we all should be frightened. As constructed only the upper chord of the LW assembly is attached to anything that is structural. The upper chord is resting on top of the exterior walls (which they stated is filled with rebar and mortar) and the lower chord doesn't even touch the wall, which would not help with carry the load. The employees stated that when the roof has snow on it, the bottom chord will then touch the exterior wall.

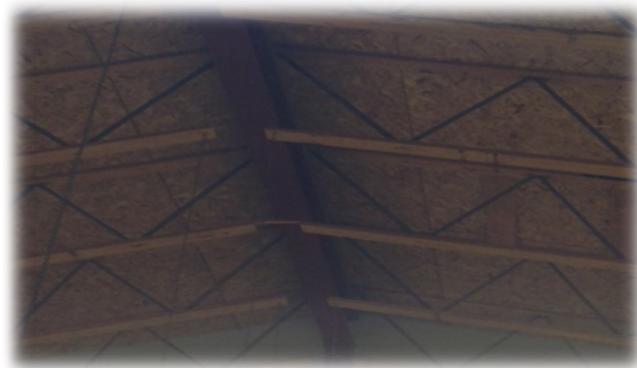
In this picture you can see the trusses are only attached to the top of the "I" beam via the upper chord. Also the lighting is attached to the bottom chords. Again, lightweight construction works as designed but when being attacked by the products of fire, they do not withstand the attack and WILL fail. In the words of Vincent Dunn, "Never Trust a Truss".
